Prevention solution for corrosion issues in CO₂ removal units in ammonia plants

Case Study Report

Doc. No: AKH01-STD-ENG-RPT-001

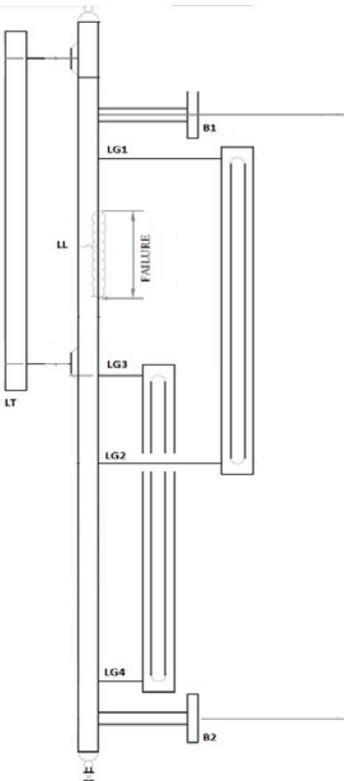
Figure 1. Level Bridle Arrangement

The bridle is made up of two nozzles attached to the tower (B1 & B2), four nipples attached to two separate level glasses (LG1, LG2, LG3 and LG4) and two further nipples attached to a level transmitter LT, all of which provides the level of Benfield solution within the absorption tower – Figure 1. The normal level during operation is as indicated in Fig. 1 (marked “L.L”) and operating data for the level bridle pipe is given in Table 1.

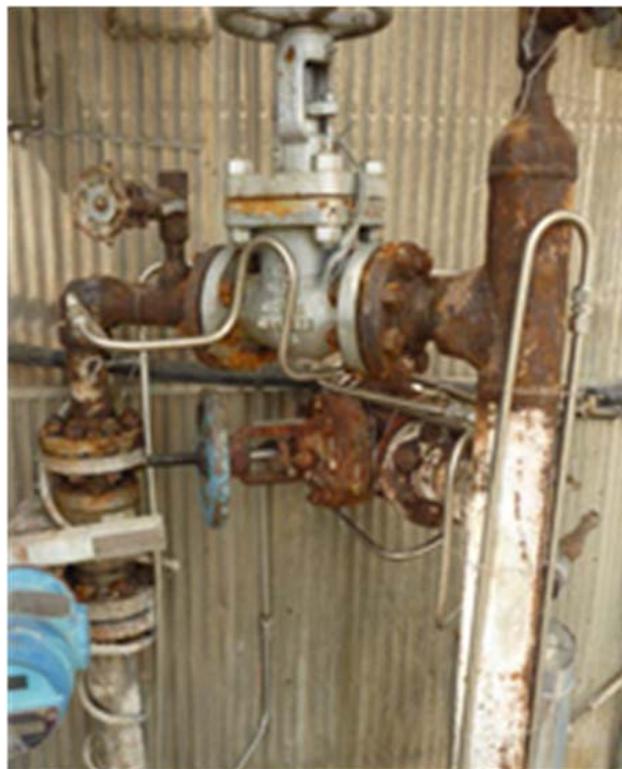
Figure 2. Failed level bridle

The failure occurred in the form of a sudden, total loss of containment with no previously identified leaks in the area. A section of the bridle was found to have peeled off. The failure took place directly in line with nozzle B1, approximately 1ft 3 inches below it. Upon inspection, immediately after the incident, vertical grooves emanating from the nozzle downwards were noted. There appears to have been some corrosive actions due to condensation of the Benfield vapour at nozzle B1 which continuously ran down the sides of the bridle wall. The appearance of the transverse part of the fracture surface is shown in Figure 4.

- The tube ruptured due to ductile overload in the result of localised thinning from internal surface corrosion.
- The source of corrosive liquid appears to be condensation of Benfield vapours at nozzle B1, which had continuously run down the bridle wall. The depth of the corrosion grooves tapered off as the general Benfield liquid level was reached.

- The appearance of the rupture indicated that the tube initially ruptured along two deep longitudinal corrosion grooves.
- The very narrow fracture surfaces on the longitudinal parts of the rupture showed that the bridle had suffered from severe local wall metal loss. The bridle wall thickness was less than 0.5 mm along parts of the deeper corrosion grooves. This thickness was below minimum required thickness to withstand the internal pressure of 400 psig (~28 bar) [3] and suggested that the rupture was initiated due to this reason (mechanical overload).

- Upgrade bridle chamber assembly at the next turnaround to stainless steel material, this way avoiding the complexity of not knowing if passivation takes place or not.
- In the corrosion study reviews, chambers and attachments to pressure equipment such as this should be classified as separate component for a better definition of the potential damage mechanisms according to the corrosion loop. As such it should also have its own detailed inspection plans.
- Review the passivation procedure for potential ‘dead leg’ areas in corrosive systems.
- Improve the process of draft inspection plan (outcome of RBMI) to the detailed equipment inspection plan to ensure nothing is taken for granted or not included.
- Regularly inspect the carbon steel bridle chamber installed until the next turnaround cycle.
- Review papers on condensation corrosion in ‘dead legs’.
